# Home Inspection Report

21 Millbrook Cr, Toronto

Prepared by  
APG Home Inspections  
Adrian Guertin, PMP, CMI, CCHI  
[www.apghomeinspections.ca](http://www.apghomeinspections.ca)

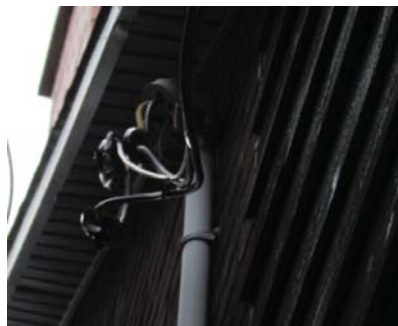
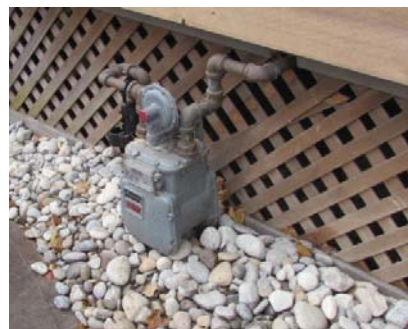
Overhead Service: Secure  
Gas Line to House - 1" Feed

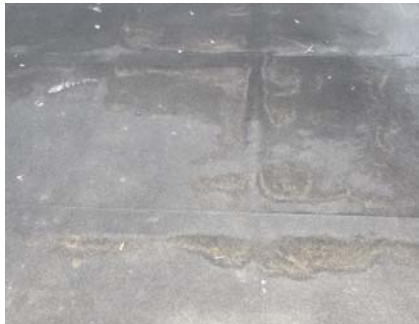
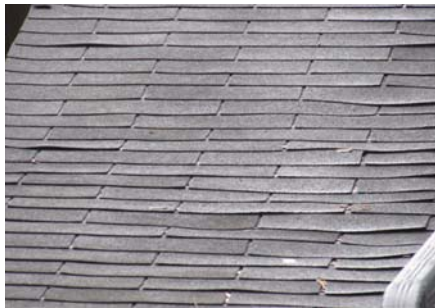
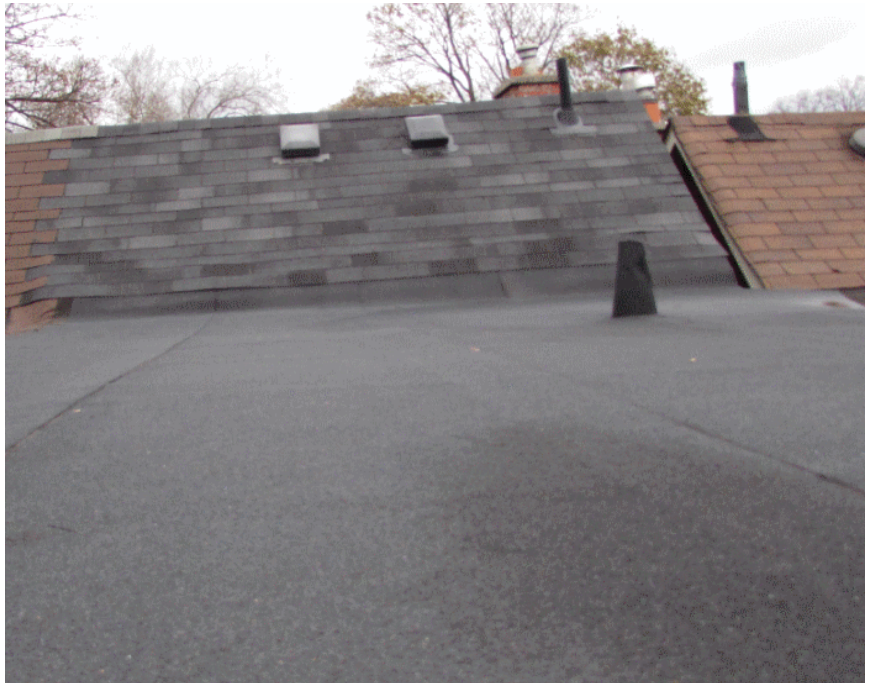
Flat Torched Membrane  
Standard Shingles  
Roof Observed to be in Very Good Condition

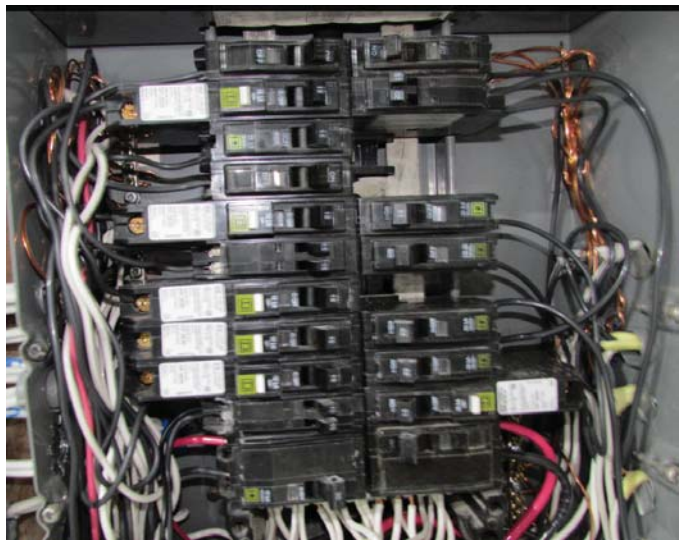
Good Condition  
Copper Wiring  
Breaker Panel

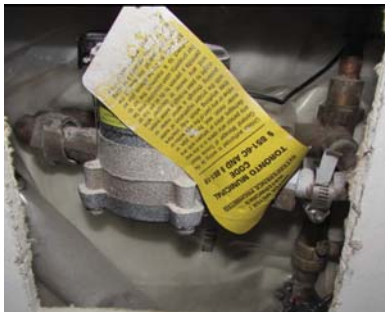
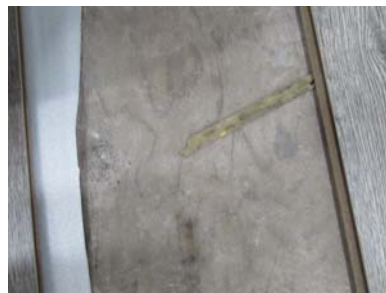
- 1- Main Water Disconnect
- 2- Backwater Valve Access - Basement Floor

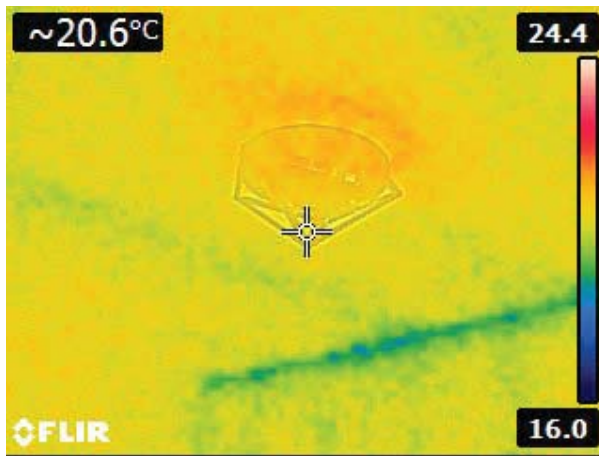
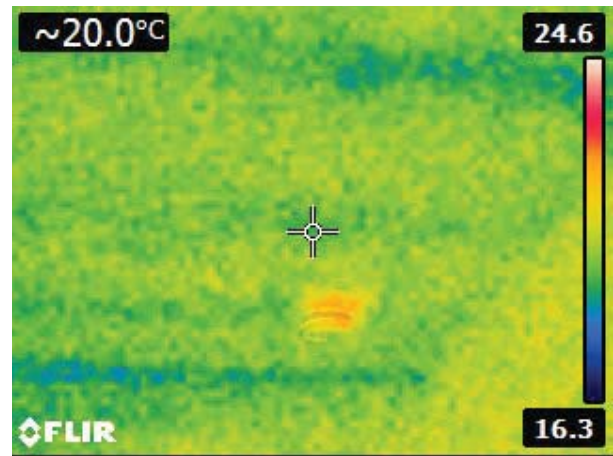
Thermal Imaging Normal  
Ceilings Well Insulated

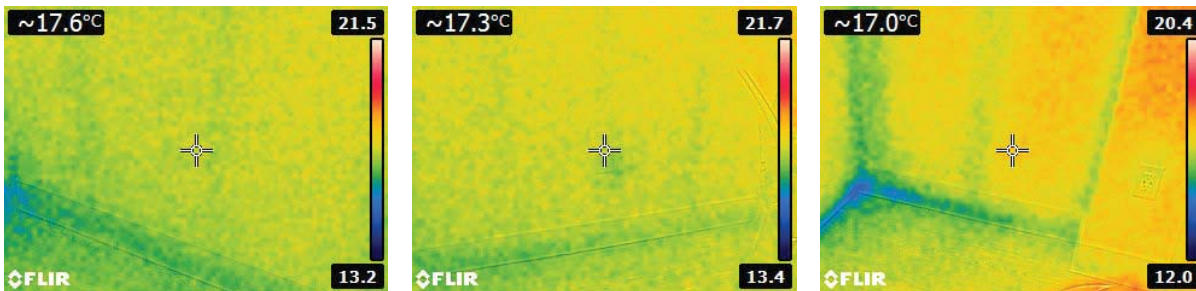
No Damages Observed  
Good Overall Condition

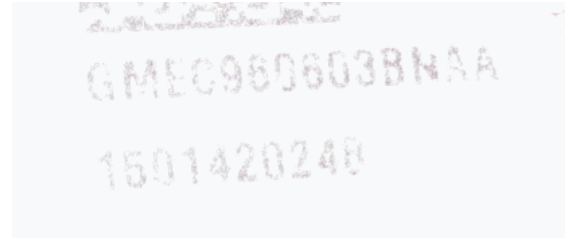
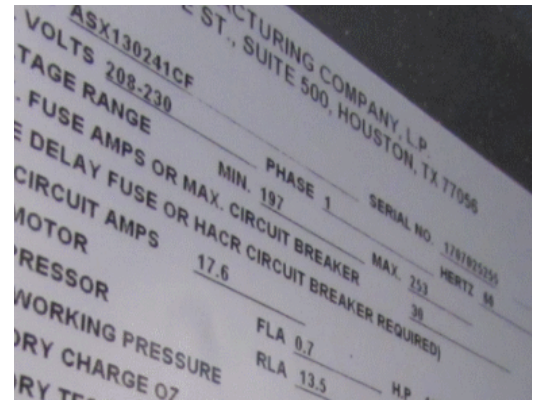
Newer Furnace and AC  
 Newer 40 Gallon HW Tank  
 HVAC in Excellent Condition
